## **The Study on the Usage of Interior Space in the Old Wooden Row Houses to Support The Elderly**

**Winai Mankhatitham<sup>1\*</sup> and Narong Butfang<sup>2</sup>**

### **Abstract**

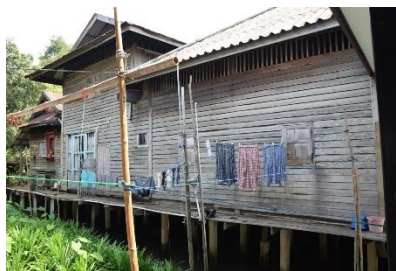
**Figure 1:** Characteristics of the Old wooden row houses

There were 2 types of the roof characteristic, which the type 1 was Hip roof and type 2 was Gable roof, with eaves connected to prevent sunlight and rain.

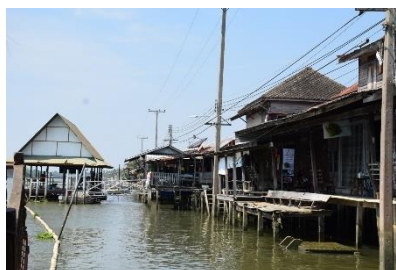
**Figure 2:** The front of the house, next to the waterfront walkway

The fronts of the old wooden row houses, Bang Nok Khwaek waterfront faces Mae Klong River, stack a wooden pole into the river, lift the house floor away from water and built the consecutive walkway

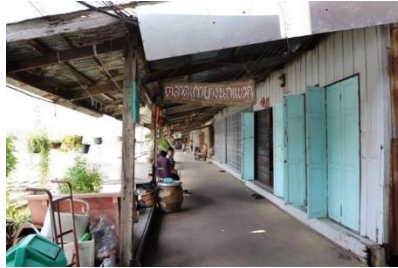
**Figure 3:** The width of the walkway was approximately 2.50-3.00 m.

bridges for walking in the community. Inside the old wooden row houses were divided into 2 parts, which were the front part that opened as a shop with space for trading and placing the goods and the back area was residential, which consists of a hall, bedroom, bathroom, kitchen and dining area. The walkway bridge was approximately 2.50 - 3.00 meters wide

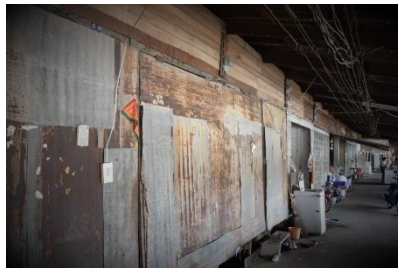
**Figure 4:** The casement door that made of tin

Next to the front walkway, there was a port for cargo handling and get on-get off. The side of the waterfront house was look like other residential except for the front door of the waterfront shop was made as an accordion door and the casement door that made from tin.

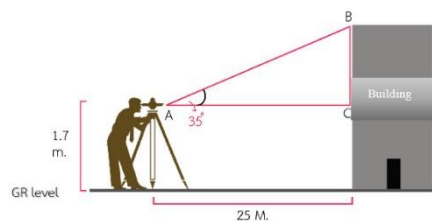
**Figure 5:** Data Collection by the Survey

4.1.2 Calculated from the formula  $\tan A = BC / AC$  is the method of finding the height using the height altitude meter. Set far enough away from the building Capture the camera at eye level, A-B point.

4.1.3 Tilt the camera up and down to the highest level and record degrees (A)

4.1.4 Recording distance from the camera to the building. Suppose the figure is 25 m. The height from the camera level to the ground is 1.70 m.

4.1.5 The process of substituting values in a formula will get a variable value,  $\tan 35^\circ$ ,  $AC = 25$ , when we get the variable We will replace it in the formula  $\tan 35 = 0.7$ ,  $AC = 25$ . The new formula is  $0.7 = BC$ .

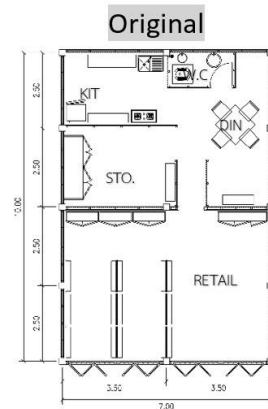
**Figure 7:** Shows the utility space, house number 16 – 17

- The backyard area has an open kitchen and bathroom.
- Inside the house there was room partition that has been built to store the goods for trading.
- The area in the front was for trading during the day and used to sleep at night.
- The utility space in the house was not has any extension and there was only the attached of a steel door for safety in year 1992. Later in the year 2013, the roof has been damaged so there was the changing of a new tin roof.

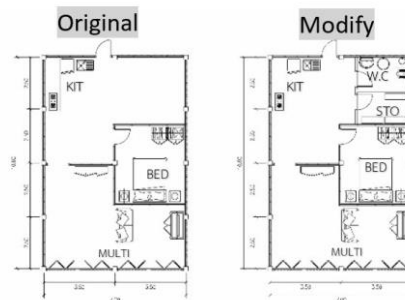
**Figure 8:** Shows the utility space, house number 21 – 22

- There were extensions of a bathroom and storage room according to the original area did not have a toilet inside the house, which caused the inconveniences

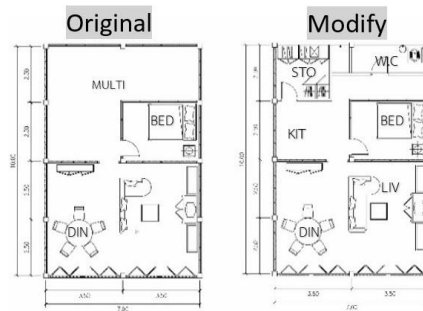
**Figure 9:** Shows the utility space, house number 23 – 24

- In year 2007, there was the extension of the interior space by partitioning the room as a dressing room and bathroom.

- In year 2013, there was the changing of a new tin roof according to the original was damaged and not be able to use again. There was an additional bathroom and storage room at the back of the house.

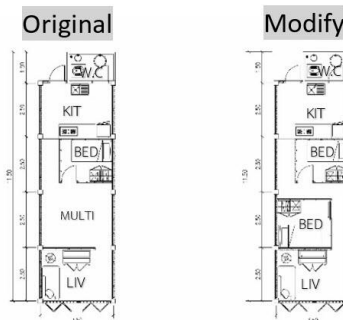
**Figure 10:** Shows the utility space, house number 27

- In year 2013, there was the changing of new tin roof due to the original tin roof was damaged.

- In year 2018, there was an extension of the room partition, which was bedroom 1 and for bedroom 2 was the original bedroom since she has been moved in.

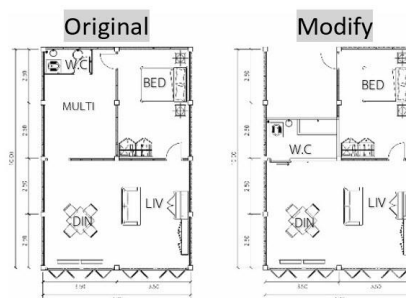
**Figure 11:** Shows the utility space, house number 28-29

- In year 2018, there was the extensions to make a new bathroom with concrete materials and repaired some parts of the floor that was damaged including the roof as well. There was a rear exit door in the bedroom.

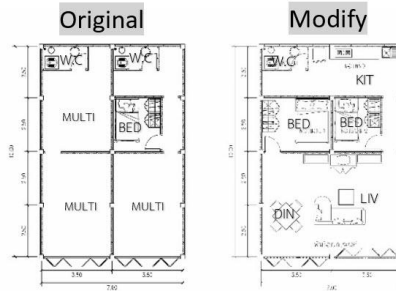
**Figure 12:** Shows the utility space, house number 30-31

At the beginning, She had rented only one room, which was room number 31. Later, in year 1997, room number 30 was resold to her.

- In year 2014, there was the changing of tin roof according to the original tin roof was damaged and could not be able to use again.

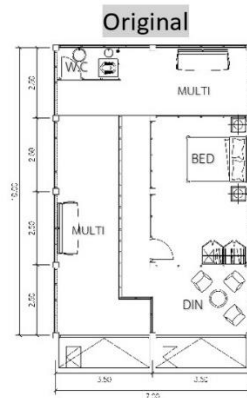
**Figure 15:** Shows the utility space, house number 36-37

- There was a partition to create a bedroom and bathroom at the back of the house. There was no exit door at the back of the house. The house owner did not change or add any space. There was only a small repaired at some places that were damaged.

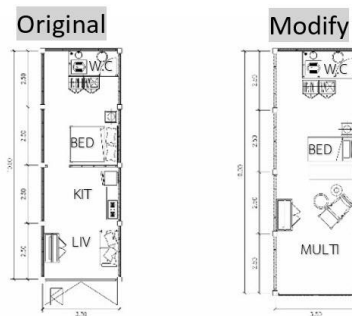
**Figure 17:** Shows the utility space, house number 42

- In Year 2007, there was the changing of all the wooden walls in the house as a smart board wall including changing to a new ceiling and removing the room wall partition and took a showcase as partition instead to prevent from seeing private area.

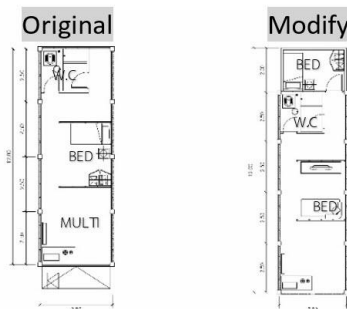
**Figure 18:** Shows the utility space, house number 43

-The front door was a steel door that extends the interior space. The front area of the house was used for trading and used as a kitchen. Next to the trading area was separated by a wooden wall as a resting area and there was a bedroom at the back of the house There were two bathrooms in the front of the second bedroom.

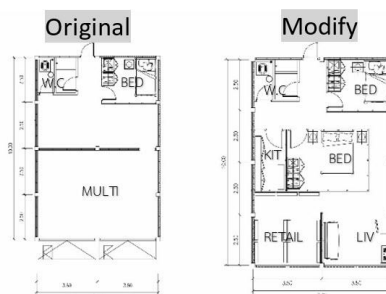
**Figure 19:** Shows the utility space, house number 44-45

-The front door was a steel door that stretches the interior space. The front area was divided into half by a smart-wall board with the left half used for trading and the right half was for a multipurpose area where the kitchen was in this area. Next to the bedroom was the storage room. At the back area were two adjoining bathrooms and another bedroom. There was a back door of the house.

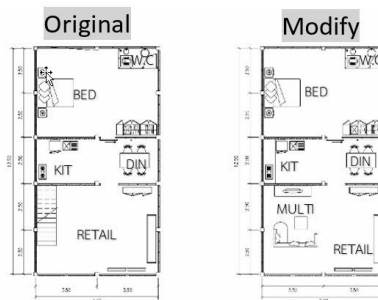
**Figure 21:** Shows the utility space, house number 46-47

-The interior space at the front of the house was used as a resting area. There was a partition with smart boards to make a kitchen and bedroom with wc. In the past, this house has been extended to the second floor and removed in year 1997.

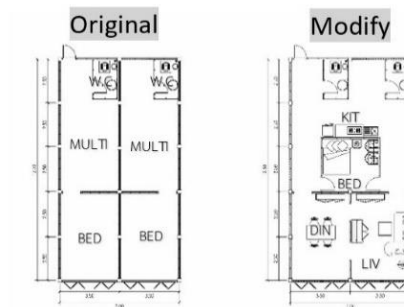
**Figure 23:** Shows the utility space, house number 66-67

- Year 2007, the interior space where the front area of the house was used as a resting area, made partition on half of the space with a smart board wall, adding new bedroom walls with smart boards. And installed additional steel doors for increased more safety. The kitchen area was an open kitchen. There were two bathrooms at the back of the house. There was an exit door at the back of the house.

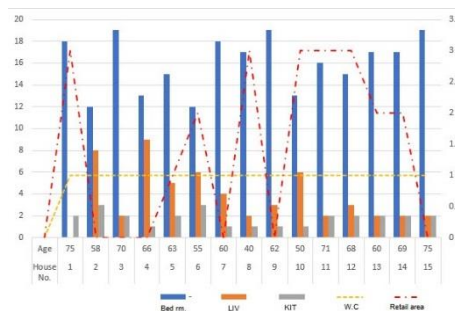
**Figure 24:** Shows the usage of interior space in the house in each day of the elderly

It was found that more than 80 percent most of the elderly spent time in the bedroom in each day because most elderly wanted to have a rest and sleeping during the day and went to bed early and woke up early. Elderly who were very old have used the bedroom area more than younger elderly. The second most used area was the parlor that was used in various activities with approximately 70 percent. Sometimes the elderly has used the sitting area and eating together. For the trading area, it was depending on the activities and occupation of each person, which most elderly used about 3-4 hours a day.

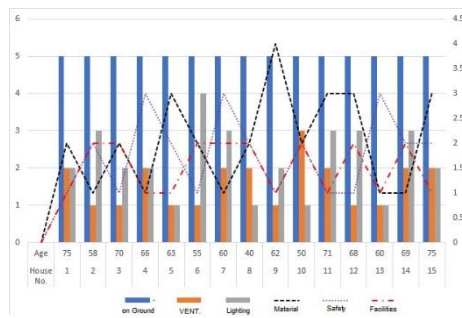
**Figure 25:** Shows the characteristics and conditions of various areas inside the house

The interior characteristic for all 15 elderly houses have a bedroom at downstairs, which was good for the elderly. Many row houses did not level the floors that resulted to the safety in using that reduced the chance of slipping for elderly (Hooi & Yaacob, 2019) There were poor ventilation and lighting because it was a row building that built continuously and there was opening in the front area only. The surface materials in the house were the most common materials, most of which are semi-glossy, semi-coarse materials such as bathroom tiles, wood flooring and so on, which enough to help ensure a moderate level of safety. As for other facilities that help to facilitate the use of elderly inside the house were still quite a few because most elderly were lack of the understanding in using of those facilities. So it made them him thought that it was not necessary and wasting costs such as handrails in the bathroom. Changing the toilet from squatting to flushing as the bathroom area was the area that needs to be improved for the most suitable using because it was the highest risk area to cause accident in the house.

1. The general area inside the house did not have problems and obstacles to the living of elderly.
2. Should increase ventilation by Should increase ventilation by using mechanical systems to help such as installing ventilation fans on the roof to help to draw more air from the front into the house by using passive design principles (Aflaki, Mahyuddin, Al-Cheikh Mahmoud, & Baharum, 2015)
3. Should increase the light in the area that the elderly use regularly, for example the stairway area or areas with obstructions and should use light-colored walls such as white, light blue and cream to help brighten the room more (Piriyasurawong & Buasri, 2017)

- 4.1 Change the doorknob to be able to open from the outside (to prevent the unconscious elderly in the bathroom).
- 4.2 Change the bathroom tile flooring material to rough type and slip sheets at the shower area.
- 4.3 Add handrails for the toilet and shower areas to enable the elderly to balance the body.
