Laboratory Studies on Soil Characterization of Earth Slope Failure at Dessie South Wollo Ethiopia- A Case Study

Abstract

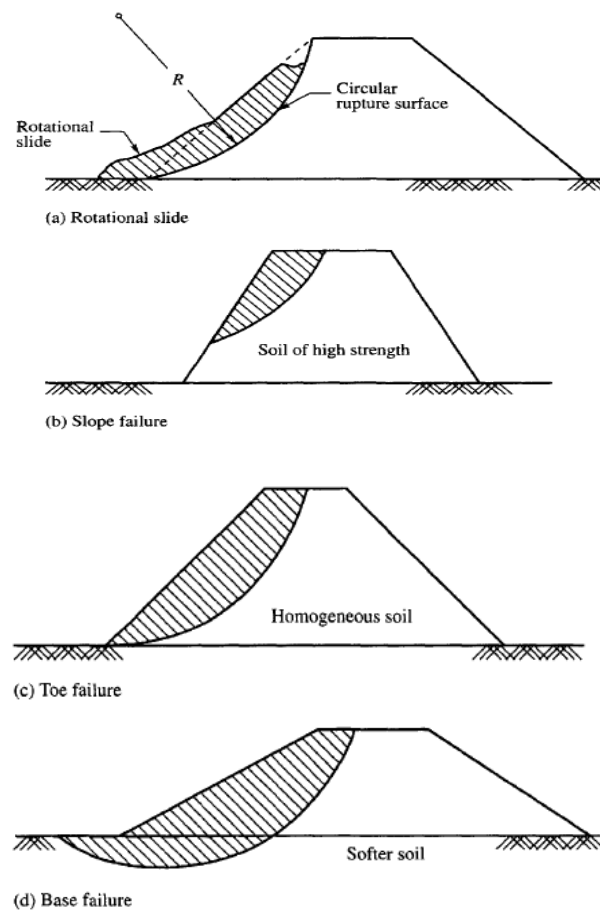
Fig. 1. Types of slope failure

Basically, there different types of slope failures but these failures are common in slope failure as shown in figure.

1. Rotational slide
2. Failure of slope in high strength soil
3. Failure of Toe in case of homogeneous soil
4. Failure of base in soft soil

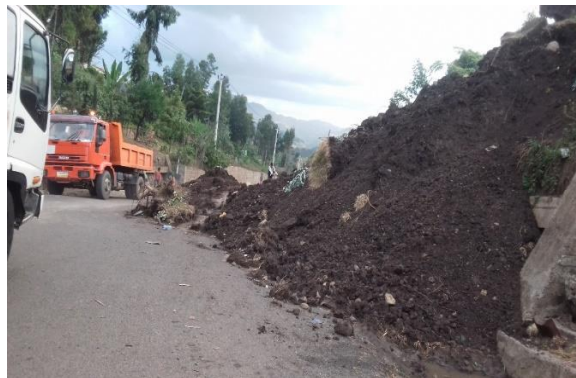
Fig. 5. Failure of earth slope covered almost half of the existing Kombolcha to Dessie Road

The slope failure presented in this work has been observed around “Menberetsehay” on the way from Dessie to Kombolcha highway road. It was clear that the existing road width was obtained by cutting the adjacent steep ridge. However, the toe cut for the road way has triggered several shallow failures in that area. Apart from this during the construction of the road, the existing spring water with significant flow rate has been buried close to the toe part without providing any drainage system. The local communities are still believing the main reason to the failure are the construction of the road in such loose soil mass and secondly the influence of the water pressure present in the pores trigger failure to the loose soil material. The movement covers almost half of the compound of Menberetsehay School and adjacent residence areas. The presence of several damaged class rooms, offices, nearby houses, trees clearly give witness to the presence of unstable movement of soil mass. Current active failures are reinitiated as a consequence of heavy rainfall. Some remedial measures like masonry retaining walls, piles were provided previously to reduce the slope movement. But, none of the adopted remedial measures were effective as observed during the site visit. The impact load of the moving soil mass has also caused failure of the retaining wall. Currently, the transported soil mass has blocked full of the road width affecting the function of this important route public transportation as shown in figure 5 and large cracks in the soil have occurred as shown in figure 6.

From the above experimental demonstration, it is concluded that, the type soil present in the soil slope failure is identified as black cotton soft soil mixed with sand particles almost 75% of soil is silt and soft clay, therefore it is concluded that the swelling potential of the soil is very high. From plasticity index chart it is observed that the plasticity index I_p of the soil is very high, therefore large cracks are appeared on the surface the soil. The clay mineral which is present in the soil is identified as commercial illite/bentonite. The main causes of soil slope failure are identified as the presence of spring water in the soil slope, the factor of safety provided is very less hence resistance to slope failure is less. The shearing strength of the soil is very less and low bearing capacity, bulk unit weight of the soil is less. Huge amount of soil is transported by storm water and deposited in slope form before many years. The remedial measure provided and suggested a reinforced concrete cantilever retaining wall.

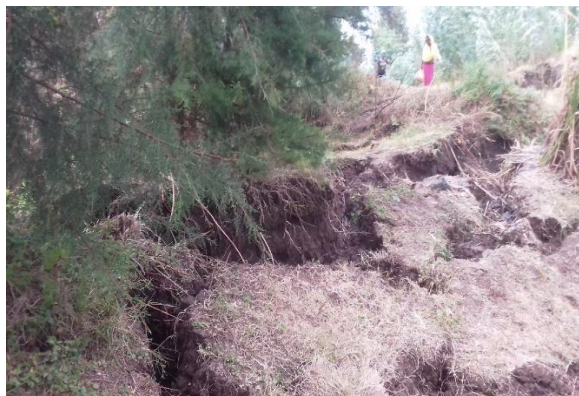
Fig. 6. Large Tension cracks appeared in earth slope failure

The failure mechanism of earth slope influencing due to seasonal variation in the environmental, during summer season due to hotter climate the soil shrinks in its volume and during winter and rainy season the soil will increase its volume so due to increase and decrease in its soil volume large crack in the soil will appear and soil mass may lead to failure. In rainy season the rain water will percolates in the soil mass through voids and the soil will become saturation and the shear strength of the soil will decrease and soil slope may slide or failure take place. This failure mechanism may take place in the presence of black cotton soil. The soil in landslide site investigated 75% black cotton soil and the plasticity index of the soil is very high so large cracks in the soil is appeared. The factor of safety is very important to protect the slope without failure. It is very important to know the failure mechanism for the analysis and design of retaining structure for the failure slope.

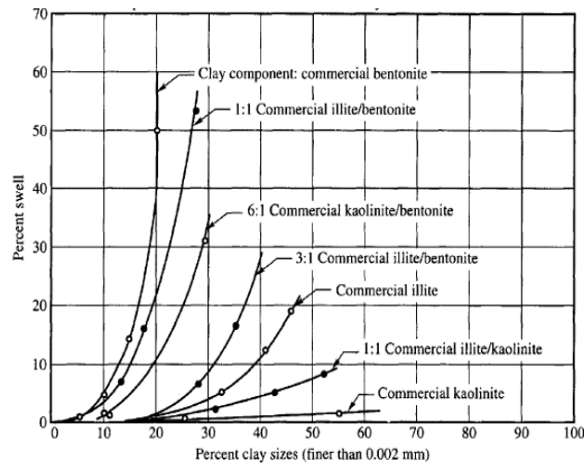
Fig. 7. Percent swell v/s Percent clay sizes

Soil colloids particles are very minute and have a large surface per unit area of mass of soil. Colloids are also carrying the electrostatic +ve and -ve charges that are balanced by the adsorbed anions and cations. Therefore, there is a direct relationship between the swelling nature and soil collides as shown in figure 7. For a given clay type of soil, the amount of swelling in soil will increases with the increase in percentage of clay soil particles. The clay mineral which is present the slope failure soil is identified as commercial illite or bentonite, this type of soil usual has more swelling and shrinkage characteristics as shown in table 5.
